## **Laser Cladding**

In cooperation with partner, Fortis Marine assists in selection of most suitable reconditioning method. Laser cladding may be utilized for reconditioning of whole range of high value mechanical parts like turbine shafts, big-size electromotor shafts, transmission shafts, piston crowns, etc.

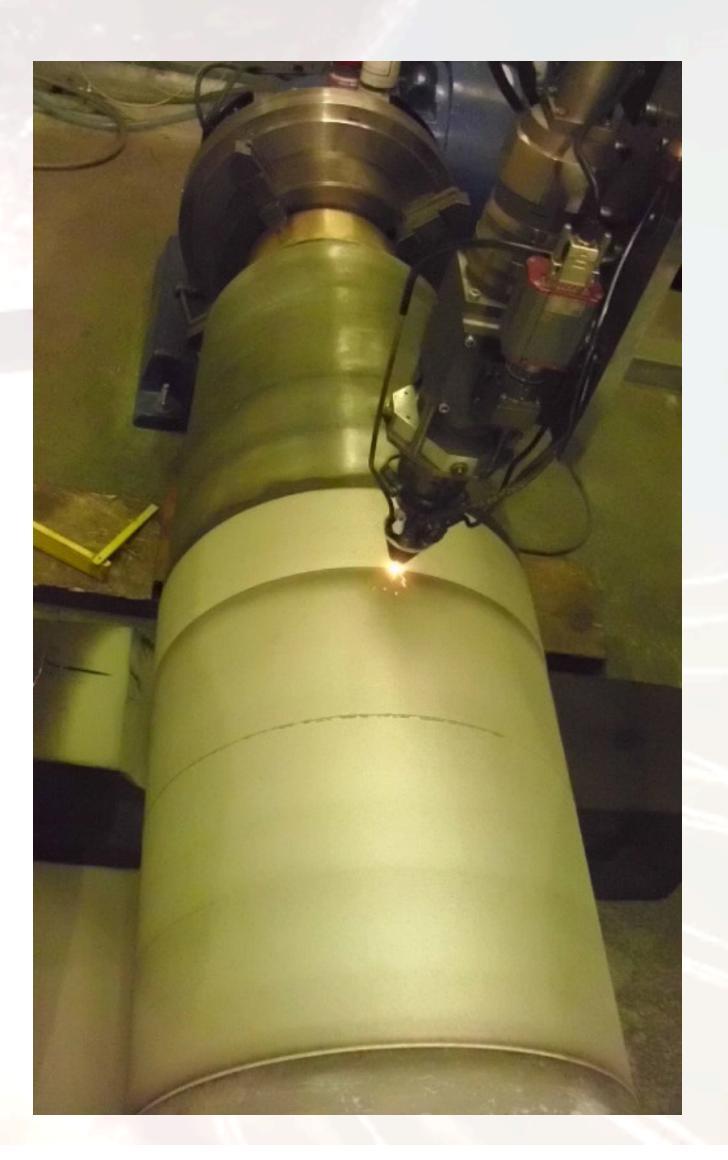
### **Reconditioning of Large Shafts**

- Cladding time 36 h
- Temperature after Cladding: 58 °C in Cladding Area
- Cladding material Stellite 21
- Local hardness and toughness increased
- High corrosion and erosion resistance

Neglected alternative: MIG/MAG-Cladding

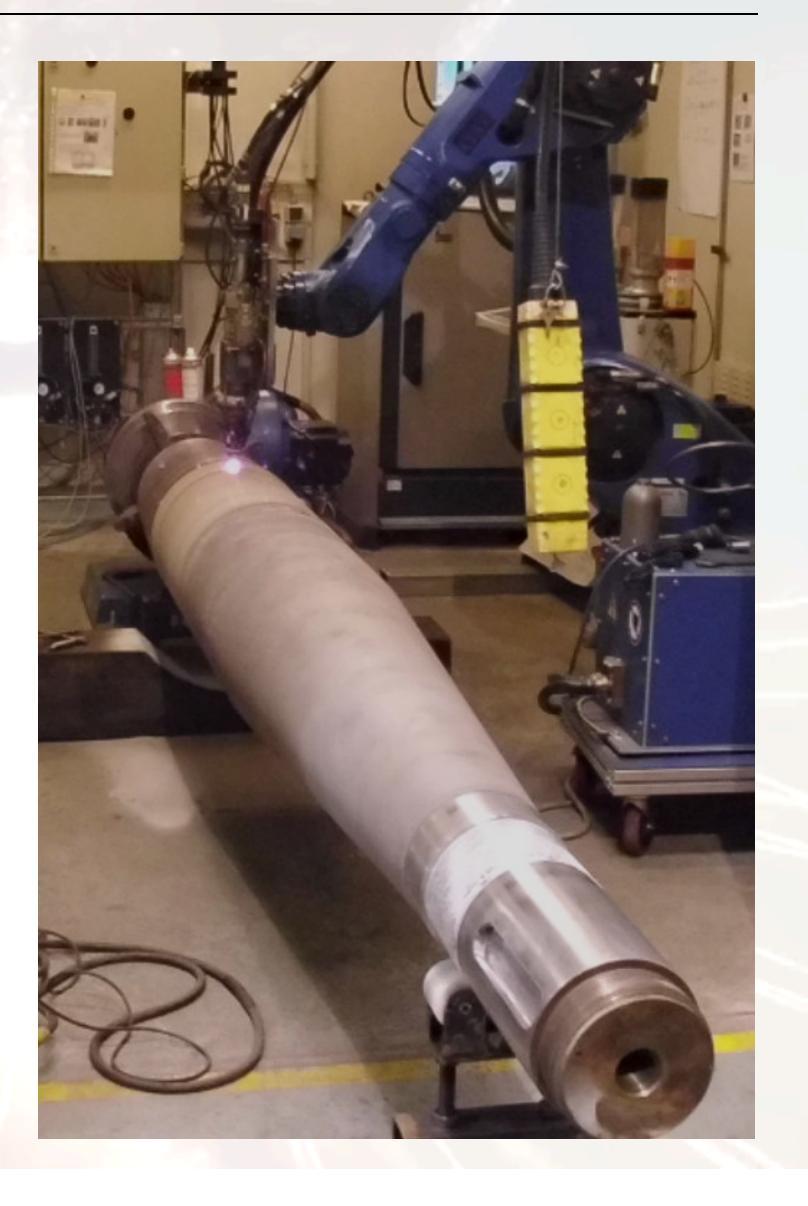
### **Reconditioning of Rudder Shaft**

Primary damage in Bearing and Seal areas

- Length of Part 3800 mm
- Diameter 400 mm
- Damage area 560 mm
- Damage depth 3 mm

### Additional damage:

- Local damage of 1/3 diameter
- Depth 6 mm
